CASE STUDY - Trunnion Refurbishment

- **Requirement:** When a mining site developed running problems with a ball mill worn journal diameters were diagnosed as the cause. Mirage have developed a system to re machine the journals to allow new bearing liners to be fitted in situ removing the need to dismantle the trunnions.
- **Location:** Australia, South Africa
- **Equipment:** Mirage SRB3000-H

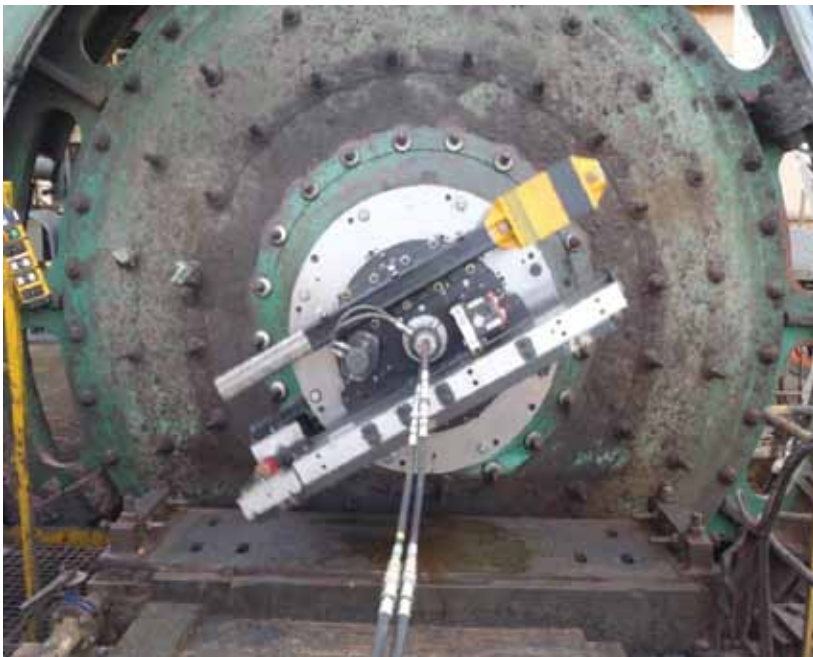
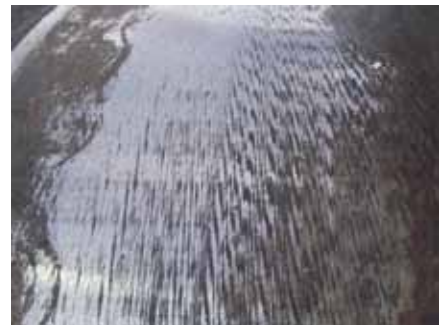
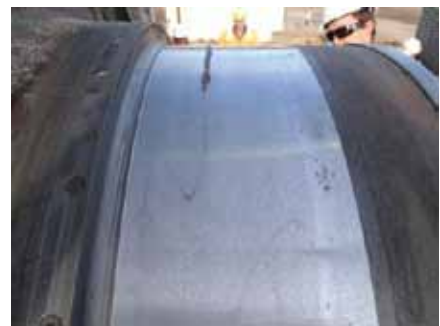
For external machining the machine has a series of mounting plates that mount directly to the trunnion and have both radial and axial adjustment to set concentricity and plane.

The machine mounts to the plate and the drop arm features angular adjustment so that the bearing diameter can be re machined to original condition and within original manufactured tolerances
