## CASE STUDY - Casing Threading

- **Requirement:** A 9-5/8" casing required cutting and extending by re threading in situ to enable wellhead refurbishment to take place. The casing required a tapered Butress thread with Api profile.
- **Location:** Kuwait - Onshore
- **Equipment:** Mirage MM300e drive and taper turning and threading attachment directly geared to give the correct thread pitch.

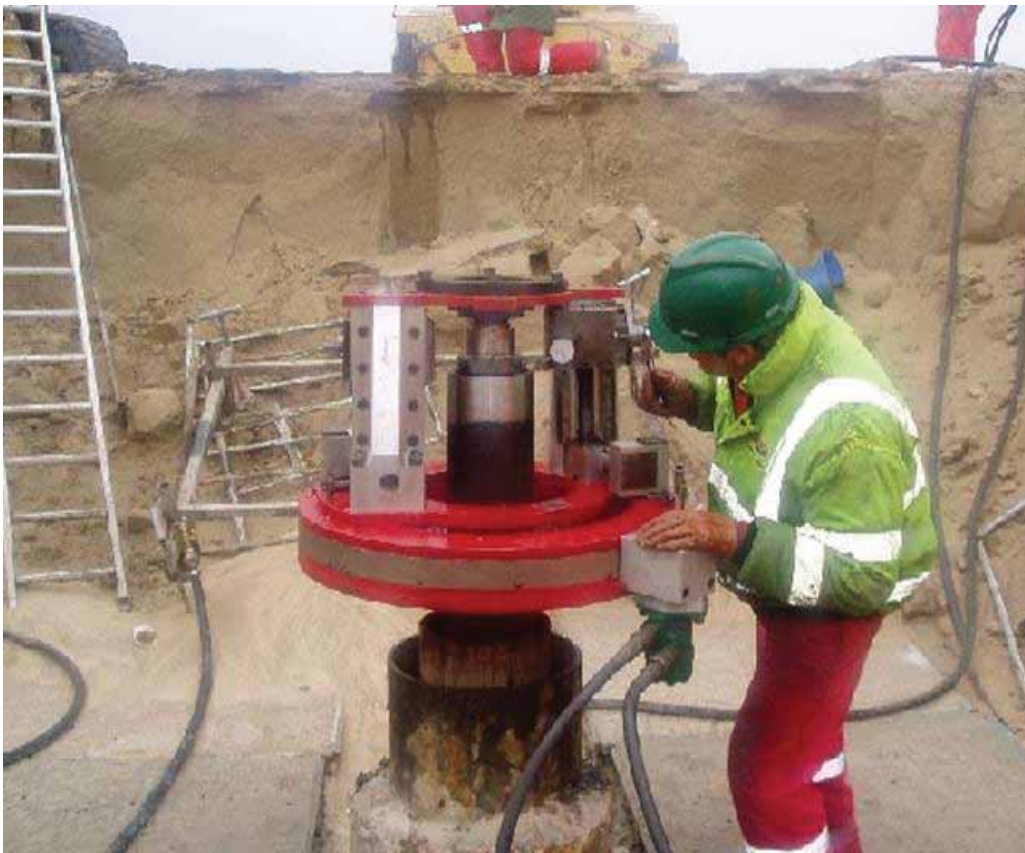
The machine clamped around the casing and was also centralised allowing quick set up true to the casing outside diameter. The turning attachment then turned the outside diameter taper.

The threading attachment was then engaged to create the buttress thread form with the correct pitch to allow casing make up.
