## CASE STUDY - Turbine Casing Refurbishment

- **Requirement:** Machine Turbine Steam seal faces
- **Location:** UAE
- **Equipment:** WB1500

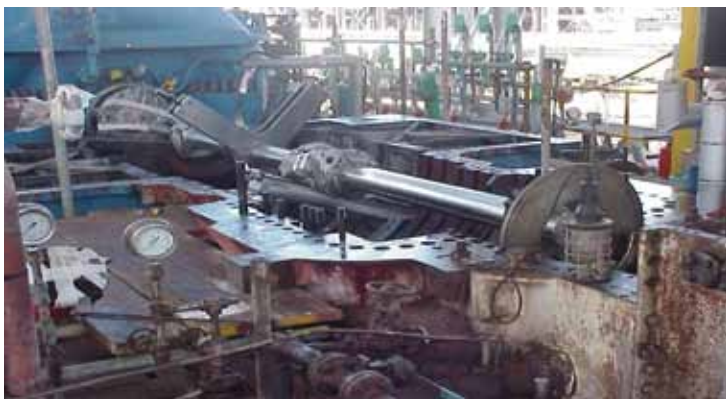
We have developed a machine to machine the steam sealing faces of a turbine case whilst they are bolted together.

We are able to machine both HP and LP stages in one setting and have also machined welded stainless steel seats where complete refurbishment of the sealing face was a client requirement.

(Above) Machine being loaded into the GE Turbine and the (left) surface finish achieved

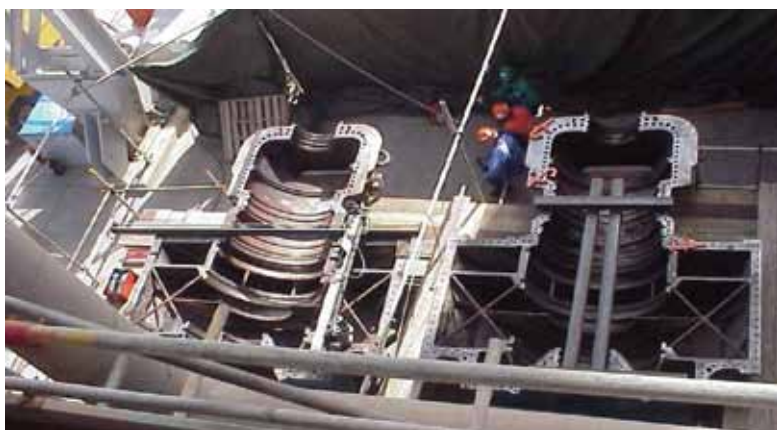
With our gantry mill and milling rail system we were able to machine the casing split lines back to the original specifications of within 0.05mm (0,002") of flatness over the whole split line. The machines were aligned using laser technology and then the welded areas were machined back to the original faces.
