## CASE STUDY - Heat Exchanger Repair

- **Requirement:** Machine heat exchanger flange face
- **Location:** Malaysia
- **Equipment:** MM1000i - MM3000i

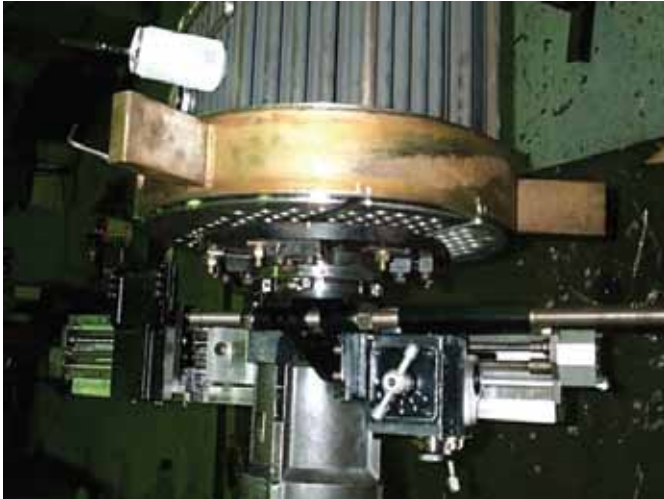
Mirage were asked to provide a machine to machine both sides of heat exchangers up to 3m diameter. Our standard flange facing machine range were supplied with specially designed mounting and jacking plates that were clamped to the heat exchanger with expanding bolts and then centralised and levelled prior to mounting the machine.

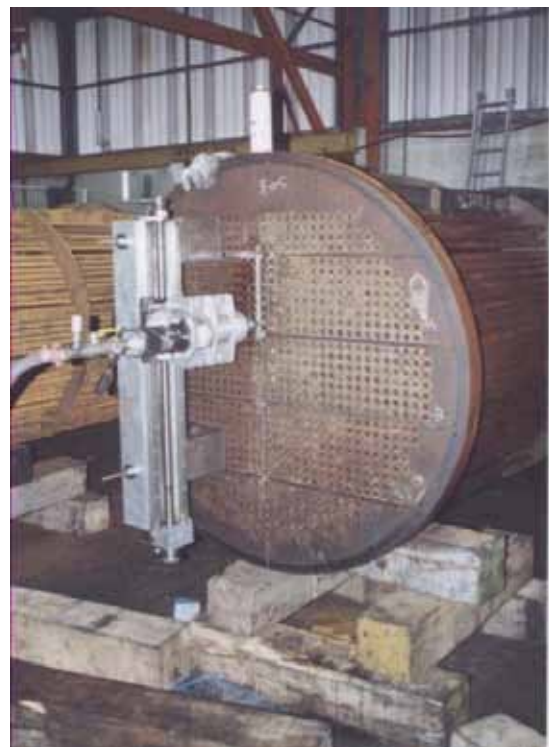
- **Requirement:** Machine heat exchanger division plate slot
- **Location:** Malaysia
- **Equipment:** MR2200

Mirage supplied a standard 2 axis MR2200 that was centralise to the division slot that had badly corroded and required welding and re machining to original specification in situ.

The machine has a two bolt mounting system that allows both fast mounting and also fast alignment. The machine is then levelled and aligned from the flange face and the division plate re-machined. Time savings are large because in most cases the exchanger can be left in place or bought into a work shop and the tubes can be left in place.
