CASE STUDY - Turbine Blade Refurbishment

- **Requirement:** Blade retainer pin drill
- **Location:** UK
- **Equipment:** PD760

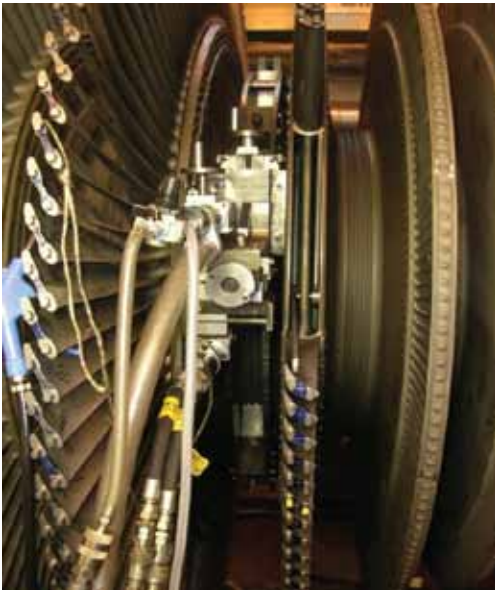
We have developed a machine to drill out the blade retaining pins when refurbishing turbine blades.

The machine removed the need to use pistol drills with fixtures and reduced the volume of tooling consumed in the drilling operation.

The PD760 also improved the accuracy of the pin drilling that resulted in a saving of 6 hours in the refurbishment process.

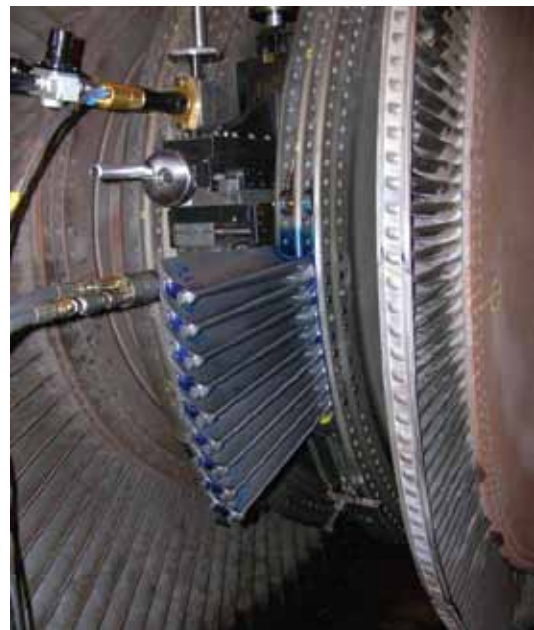
With our portable slitting machine we were asked to provide an accurate method of cutting the worn and damaged blade tips off efficiently and precisely so that time could be saved in the refurbishment process and that this would lead to also an improvement in the health and safety record of this operation.

The BLS 760 shortened the blade cutting time from 2 hours to 8 minutes and resulted in 4 complete turbine refurbishment projects with 0 accidents or LTI.
