CASE STUDY - Turbine Casing Refurbishment

- **Requirement:** Machine Turbine Steam seal faces
- **Location:** UAE
- **Equipment:** WB1500

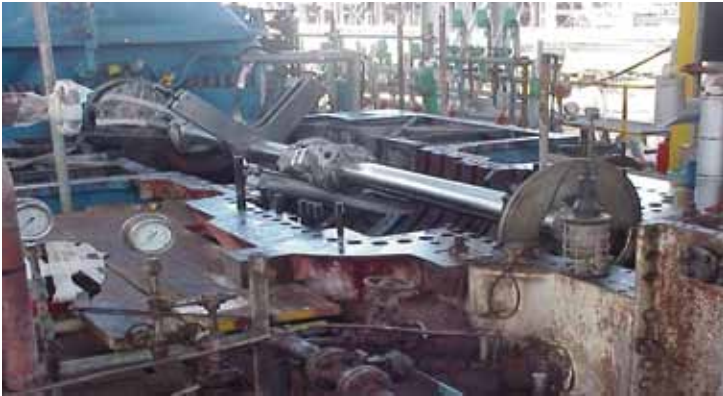
We have developed a machine to machine the steam sealing faces of a turbine case whilst they are bolted together.

We are able to machine both HP and LP stages in one setting and have also machined welded stainless steel seats where complete refurbishment of the sealing face was a client requirement.

(Above) Machine being loaded into the GE Turbine and the (left) surface finish achieved

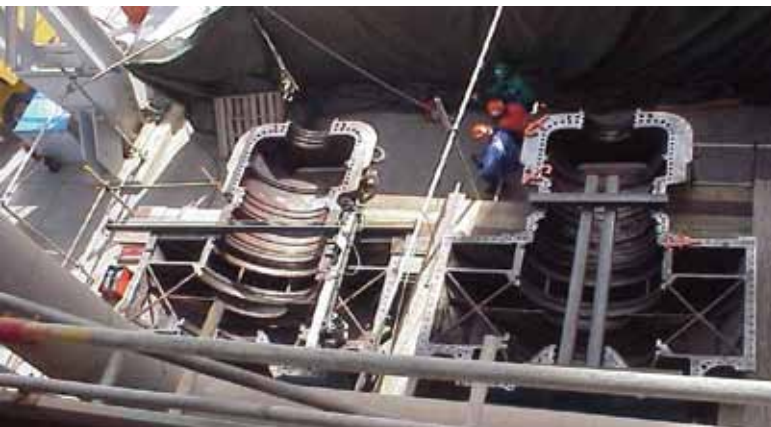
With our gantry mill and milling rail system we were able to machine the casing split lines back to the original specifications of within 0.05mm (0,002") of flatness over the whole split line. The machines were aligned using laser technology and then the welded areas were machined back to the original faces.
