CASE STUDY - Heat Exchanger Repair

- **Requirement:** Machine heat exchanger flange face
- **Location:** Malaysia
- **Equipment:** MM1000i - MM3000i

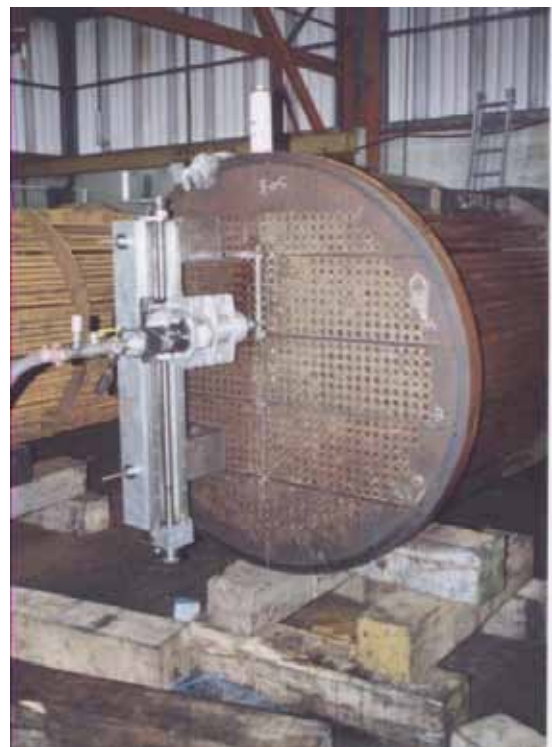
- **Requirement:** Machine heat exchanger division plate slot
- **Location:** Malaysia
- **Equipment:** MR2200

Mirage supplied a standard 2 axis MR2200 that was centralise to the division slot that had badly corroded and required welding and re machining to original specification in situ.

The machine has a two bolt mounting system that allows both fast mounting and also fast alignment. The machine is then levelled and aligned from the flange face and the division plate re-machined. Time savings are large because in most cases the exchanger can be left in place or bought into a work shop and the tubes can be left in place.
